# BRADKEN

## SUCCESS STORY

### 3" Hoist Chain

**Product:** 30HC09SS-11 - 3" Lower Hoist Chain

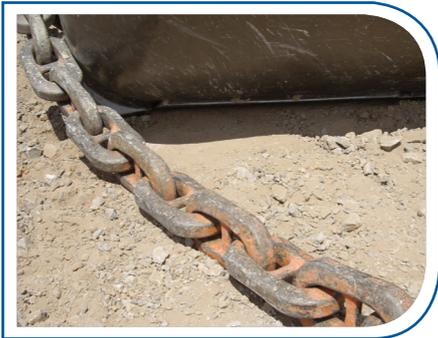
3" Hoist Chain in service

In August 2012 Bradken fitted a new set of lower 3" hoist chain on a BE1370 dragline at Isaac Plains with the assistance of Jason McCallum (Production Superintendent) in addition to an Integrated Socket Equaliser (ISE), Drag and Dump chains and **APT** Dragline rigging pins. The chain was designed to create a uniform and tangential contact face for improved wear control, along with optimised stud-end and step-up chain links to provide more crutch contact surface area.

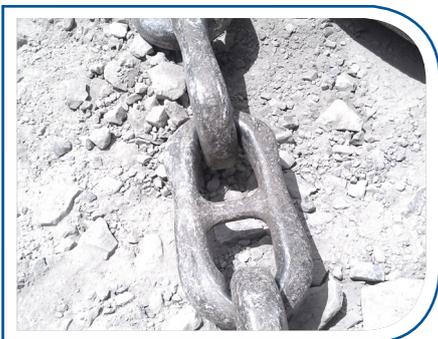
3" Hoist Chain prior to being removed

The Bradken product was compared to the previous hoist chain in service which had an average of life of twelve (12) to fifteen (15) weeks. Bradken's hoist chain almost doubled the previous maximum wear life, when it was removed after twenty-nine (29) weeks in service in March 2013.

Inspection after twenty-nine (29) weeks showed the worst single link wear in the crotch region was approximately 31.6%, whilst the worst single link rail wear was 20.4%.

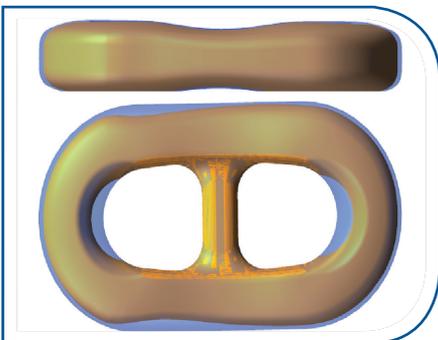
3" Hoist Chain wear overlay

In addition to the base chain product, Bradken is also able to offer customised rail treatments to prolong the life of your lower hoist chain.
